HUDSON RIVER BASIN
TRIBUTARY TO HIGHLAND LAKE
SUSSEX COUNTY
NEW JERSEY

UPPER HIGHLAND LAKE DAM

PHASE 1 INSPECTION REPORT NATIONAL DAM SAFETY PROGRAM

AUGUST 1981

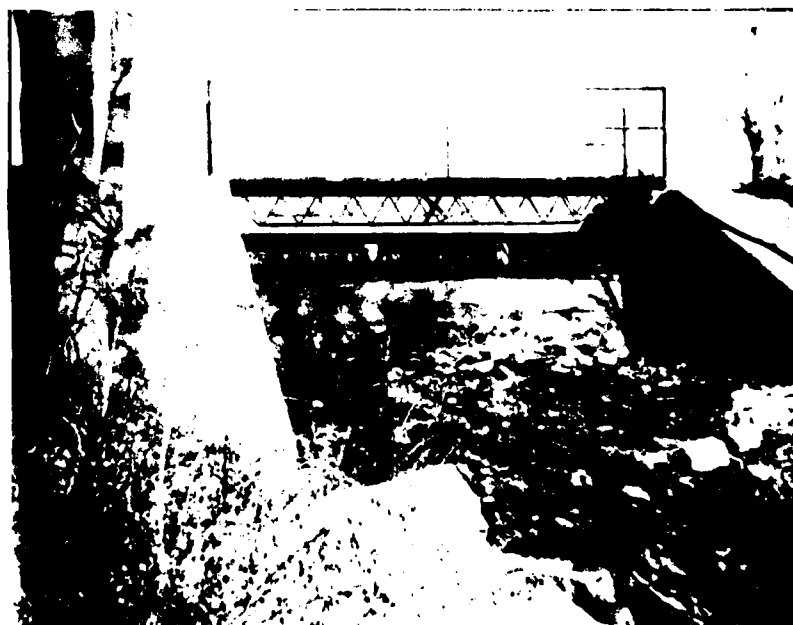
The spillway and sidewalls are in fair overall condition although some concrete deterioration, consonant with the age of the structure, was observed. Spalling and cracking of the spillway apron was observed, and a horizontal crack extended the width of the spillway about 18 inches below the top of the weir. Spalling was also somewhat more severe at the junction of the spillway slab and apron.

VISUAL EXAMINATION OF	OBSERVATIONS	REMARKS OR RECOMMENDATIONS
CONCRETE WEIR	Downstream face of weir scaling. Light spalling and efflorescence on left downstream wingwall; others satisfactory.	Repair deteriorated concrete.
APPROACH CHANNEL	Lake bottom sandy silt and gravel.	Silted to within 3 feet of top of wingwalls. Should be cleaned.
DISCHARGE CHANNEL	Channel is narrow (3 to 5 feet wide), approximately 2 feet deep, and filled with small boulders; banks are wooded.	Channel ends in 2' x 3' oval culvert, which appears to be a severe constriction during heavy storms.
BRIDGE AND PIERS	Steel truss of concrete footbridge may collect debris and constrict discharge. Bridge appears to hamper removal of flashboards.	Spillway should be monitored during heavy storms and kept free of debris. Method of removing flashboards should be devised.
	iv

March, 1981
Downstream View of Spillway

(4) All spalled and deteriorated concrete at the spillway should be repaired and the siltation on the upstream side of the weir should be removed.
